# ADVANCED TRAINING ON ENERGY EFFICIENCY IN HISTORIC HERITAGE

01 A2  
COLLECTION  
OF CASE STUDIES

**Collection of case studies**

### BRAZIL GENERAL CONSULATE

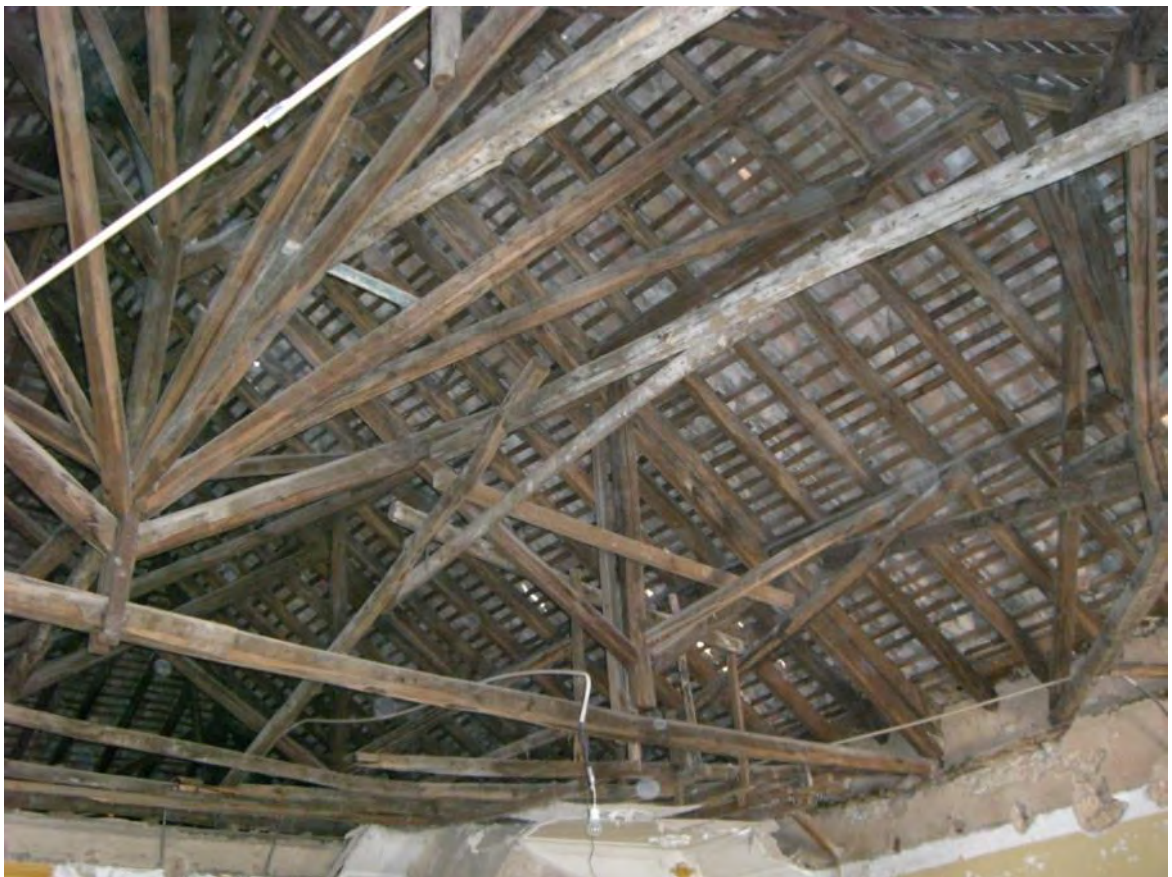
Figure 9\_ Picture of the building before rehabilitation

In the years prior to its recovery in 2007, the building had a continuing degradation as a result of not being in use. In 2007 underwent some maintenance work, but essentially covers and exterior plasters. In 2011 underwent a deeper intervention, for adaptation to non-residential use, not discriminated. The state of the building before rehabilitation is shown in Figures 9 and 10.

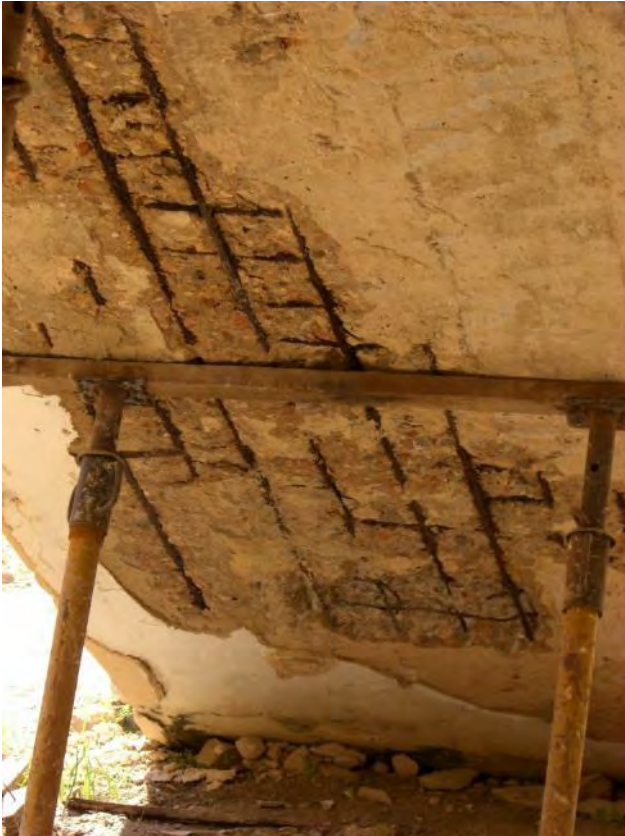
Figura 24\_ Degraded concrete slabs

In the 1937 intervention were used elements of reinforced concrete. The coatings of armor were clearly insufficient. The process of time and the presence of moisture caused an increase of the section of rods due to corrosion, so the pieces were cracked and in some points, the armor was discovered.

In some exterior elements, where the steel had a high level of corrosion, this was brushed and reinforced, and then painted with SIKA-Ferroguard, ending with the application of mortar monolayer SIKA-Monotop. (Figure 24).

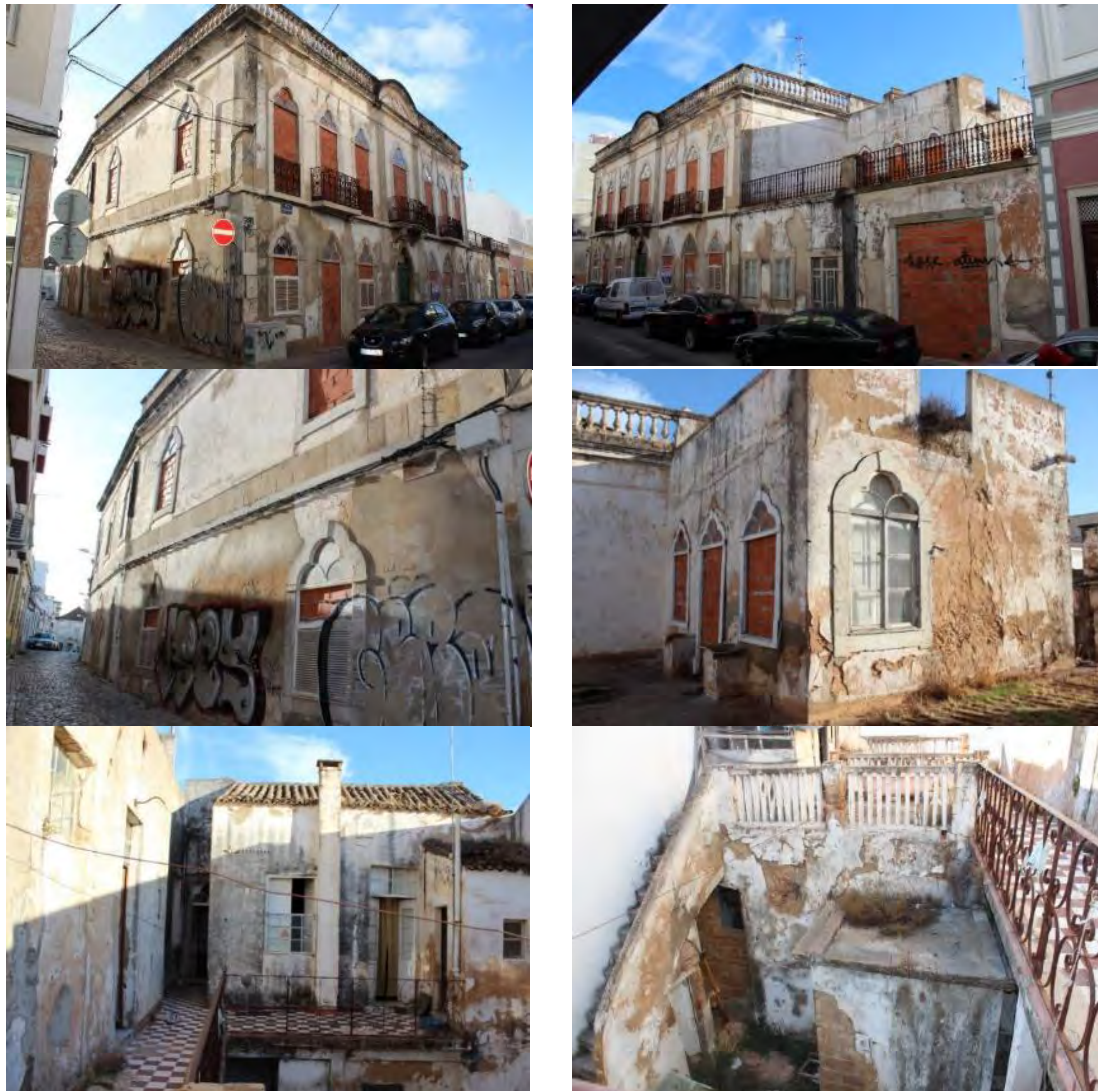
Figure 10\_ Pictures of the building before rehabilitation (October 2013)

In the last years the building had a very rapid degradation, both outside or inside, mainly due to lack of tightness of the covers and the collapse of the glazing. The owner opted for closing the openings through ceramic brick. The state of the building before rehabilitation is illustrating on the figures 10 and 11.

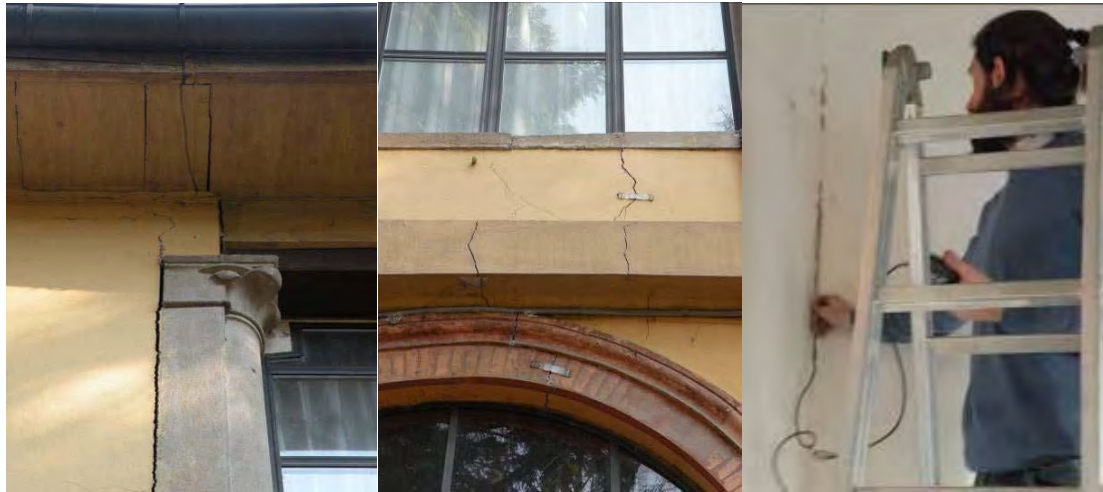
Figure 47\_ Cracks on the exterior walls in the SW side (left and centre); measurement of the air-flow through cracks from the interior with an anemometer (right)

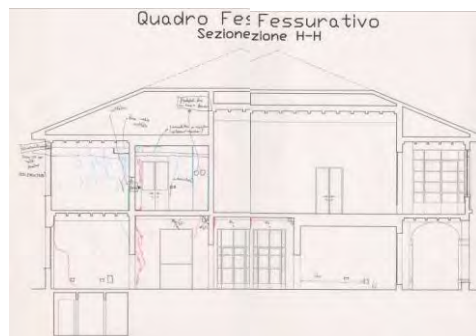
In this case the survey and drawing of the crack pattern is very important and it has been conducted in order to better understand the state of damage of the structure and its vulnerable points. An example of a sketch of the crack pattern recorded on-site is given in Figure. 48.

Figure 48\_ Crack pattern survey on a vertical section

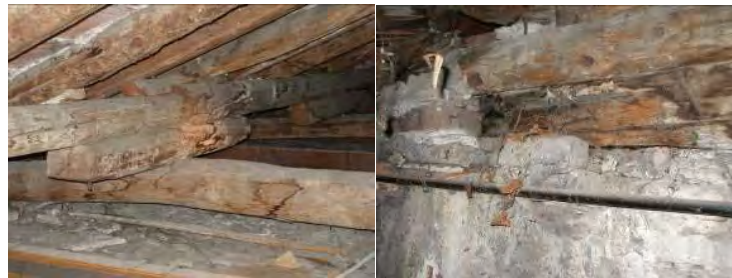
Other structural problems are related to the wooden roof structures, made of ancient, original and new timber elements; the main problems are due to the water leakages as visible in Figure 50.

Figure 50\_ – Water leakages on the wooden beams of the roof.

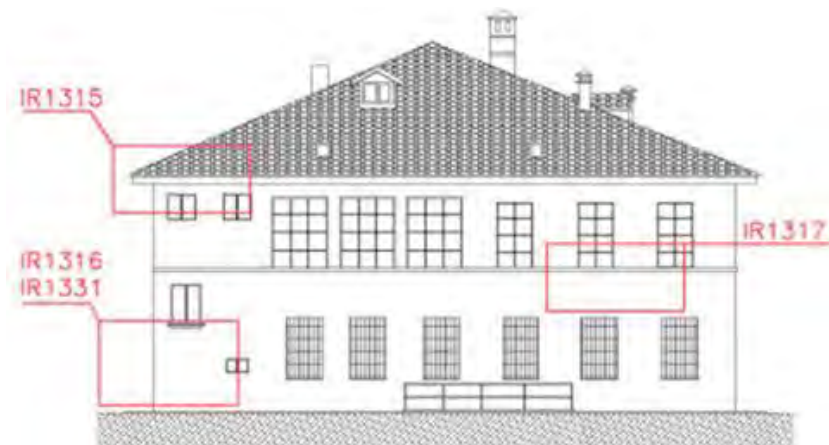
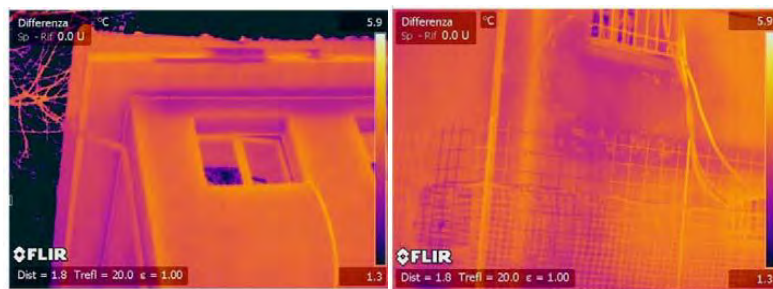
Figure 52\_IR-thermography for moisture detection, exterior wall, rear side of the building

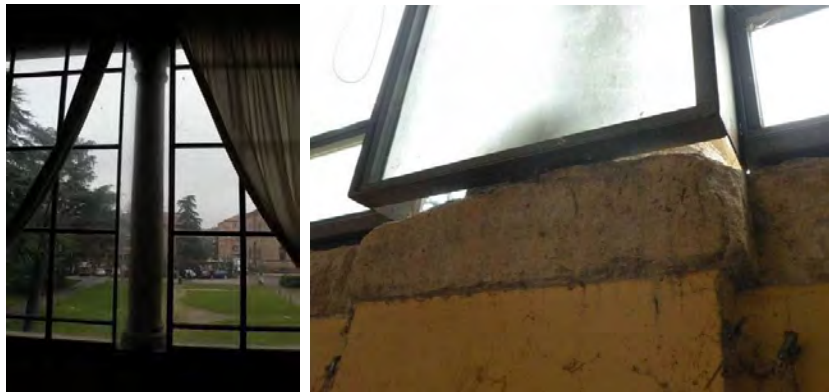
Old buildings are often characterized by a great amount of thermal losses and a low airtight level. In our case study, Palazzina della Viola, the old original doors and windows presents bad airtight conditions as reported in the following interesting images.

Figure 53\_Window frame around a masonry column (left) and detail of the opening (right), 1st floor, front side of the building.

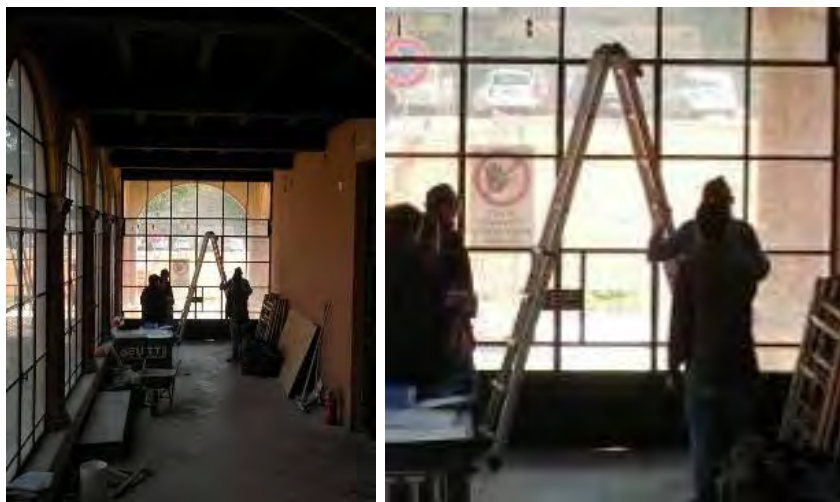
Figure 54\_Main entrance door in low airtight conditions, as visible from the passing light at the bottom

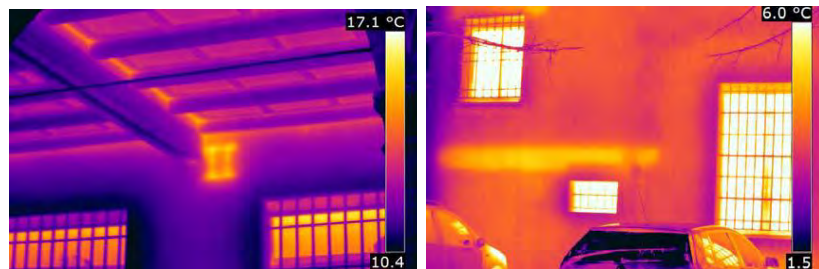
Figure 63\_ Post-refurbishment NDT of thermal bridges by IR thermography: steel beam-ends (left); concrete stairs landing (right).
