# ADVANCED TRAINING ON ENERGY EFFICIENCY IN HISTORIC HERITAGE

01 A2  
COLLECTION  
OF CASE STUDIES

**Collection of case studies**

### BRAZIL GENERAL CONSULATE

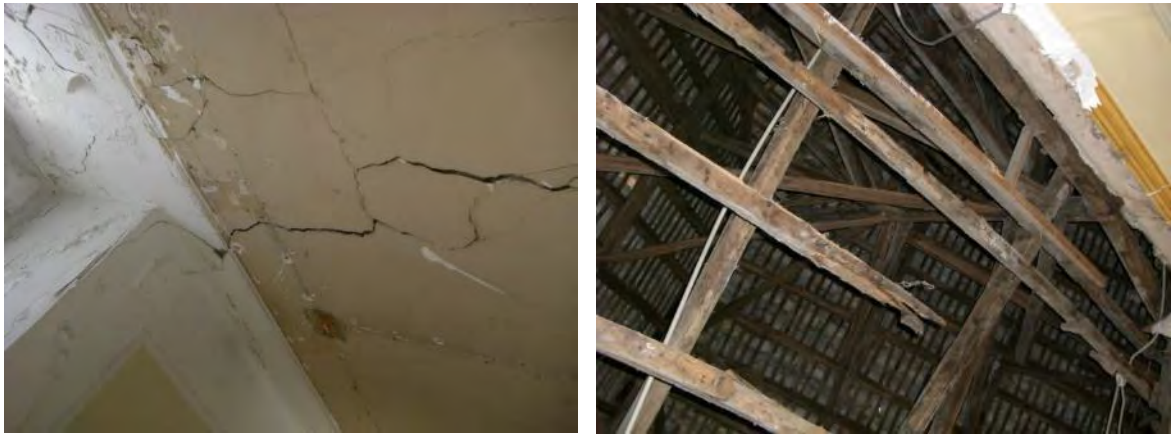
In the years prior to its recovery in 2007, the building had a continuing degradation as a result of not being in use. In 2007 underwent some maintenance work, but essentially covers and exterior plasters. In 2011 underwent a deeper intervention, for adaptation to non-residential use, not discriminated. The state of the building before rehabilitation is shown in Figures 9 and 10.

Figure 10\_ Pictures of the building (inside) before rehabilitation

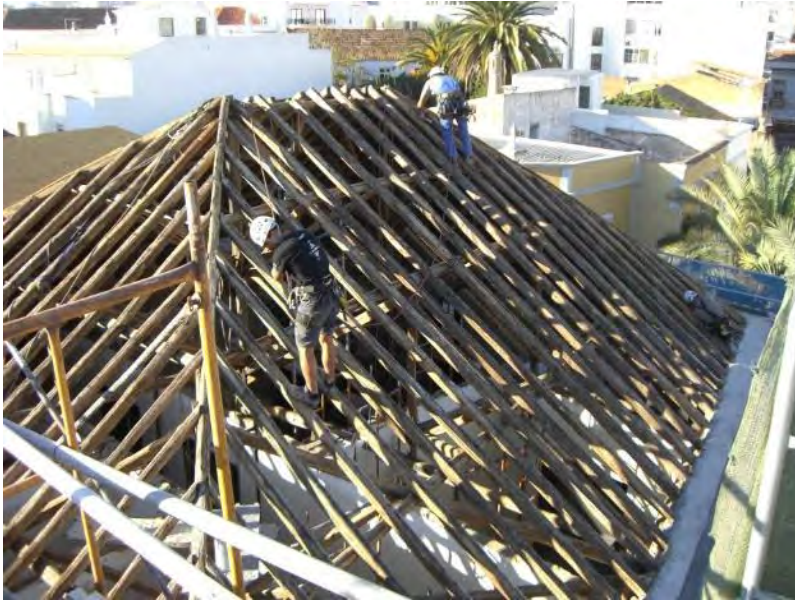
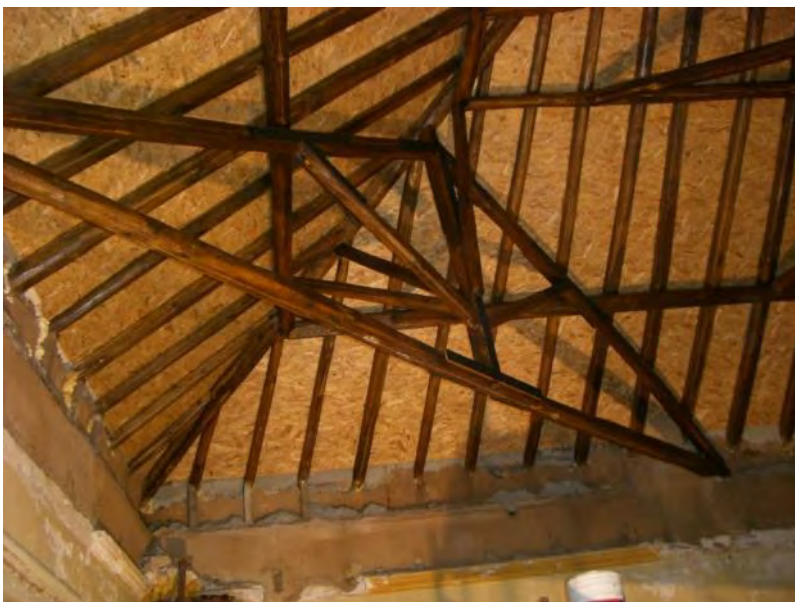
Figure 11\_ Rehabilitation of the wood structure of de roofs

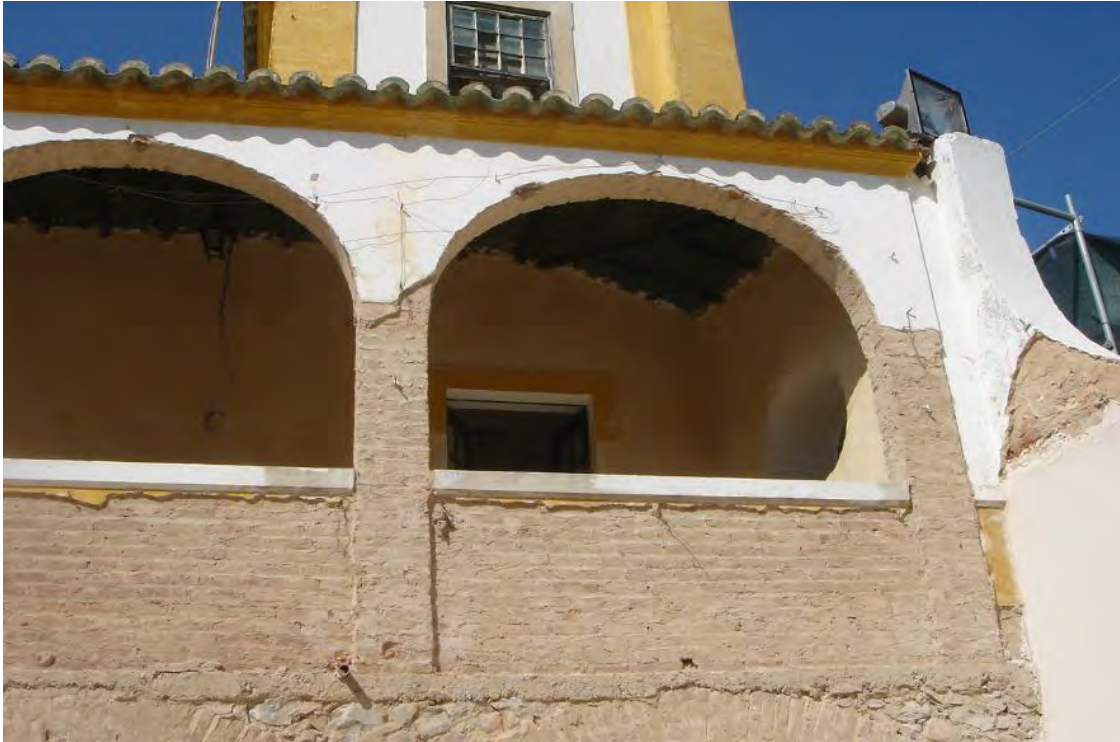
The walls were picked by removing the plaster of about 3 cm thick, which had been deteriorated due to moisture / rainfall that directly affected the walls or timber elements rested on the walls (roof trusses). By the action of moisture the wood swelled, causing detachment on the walls (Figure 22).

Figure 22\_Walls without plasters

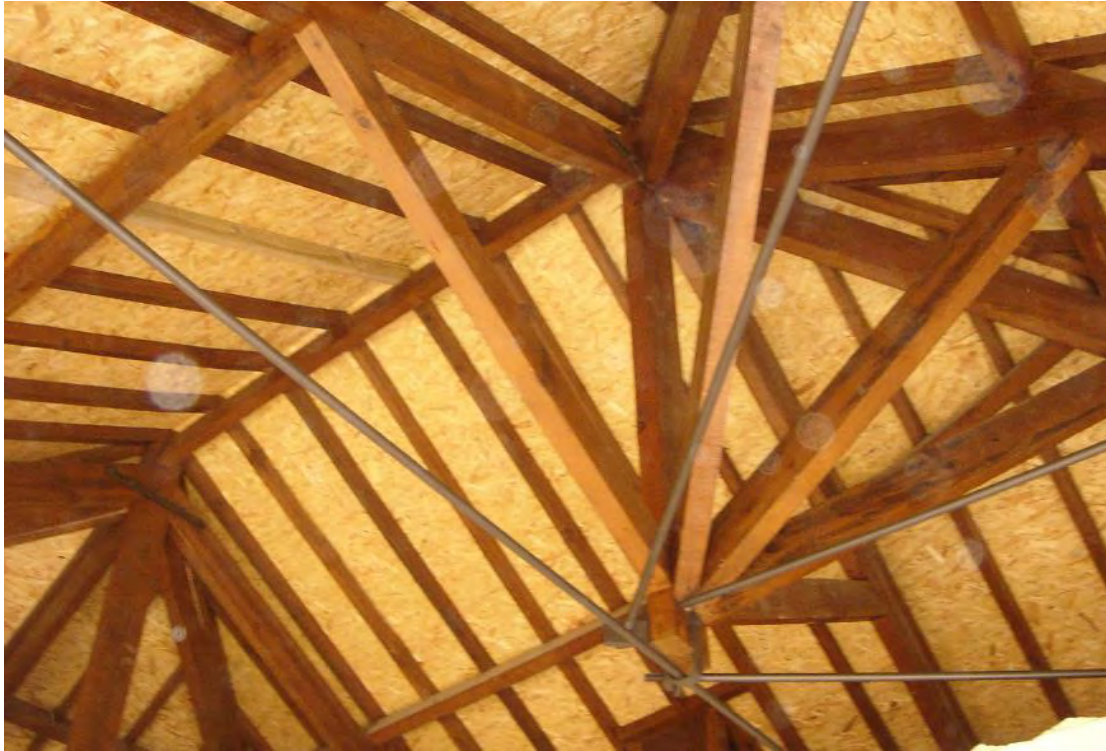
The roofs were all intervened because they were in an advanced state of degradation. Some were demolished and others were rebuilt, always with the same dimensions and architectural features. The material used was essentially wood and when needed metal reinforcements were made (Figure 23).

Figure 23\_ Intervention in roofs

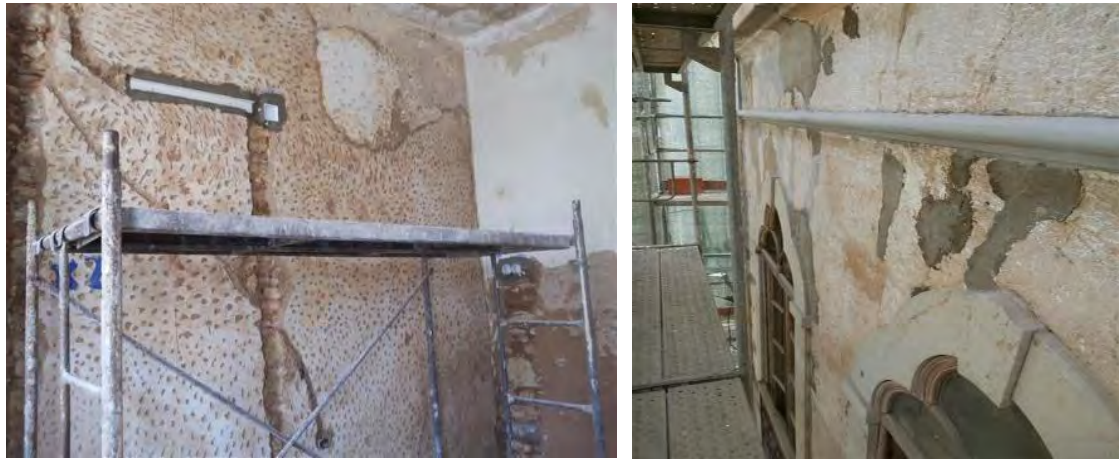
Figure 5\_ Walls without plasters.

others with limestone and lime mortar, complemented by timber according to the Pombal construction method. Thus, in general, SECIL mortars were used - rehabilitates RR or lime mortars, using fiber to reinforce the corners and the base material change zones, to prevent future cracking.

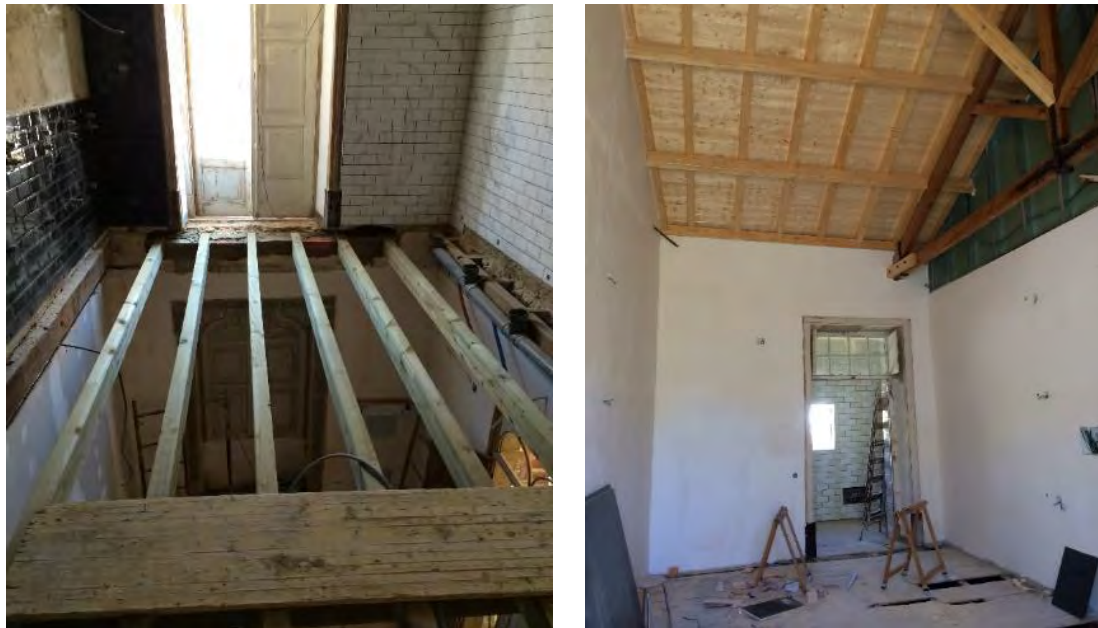
Figure 20\_ Reconstruction of floors

The wooden floors that had noise or were without resistance were replaced by new hardwood flooring, with the same construction method (Figure 20). An acoustic blanket in order to ensure acoustic isolation percussion sounds has now been applied. Where it was not possible to put it, rock wool was used on top of the existing lining.

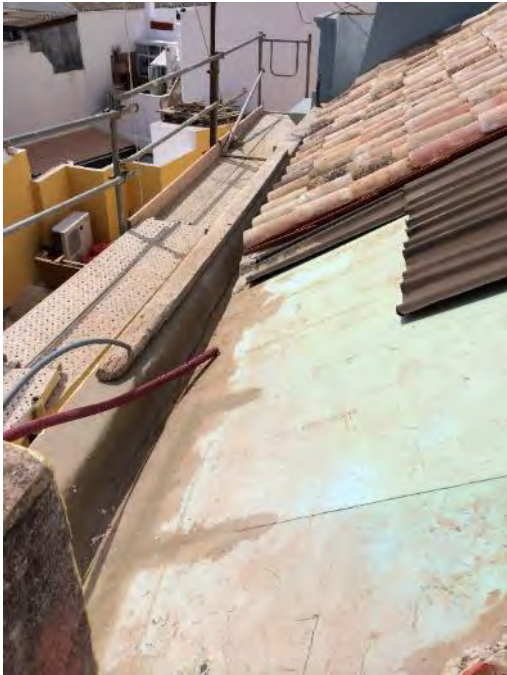
Figure 24\_ Roof thermal insulation

The roofing was all isolated integrating the following layers (from inside to outside):

- wooden trusses (in sight)
- lining casquina, male female type
- Extruded expanded polystyrene plates 8 cm;
- sub tile Onduline with isolated shots with shot screen;
- new tile to the channel and original old tile to the top of the ranks, applied with clip system.

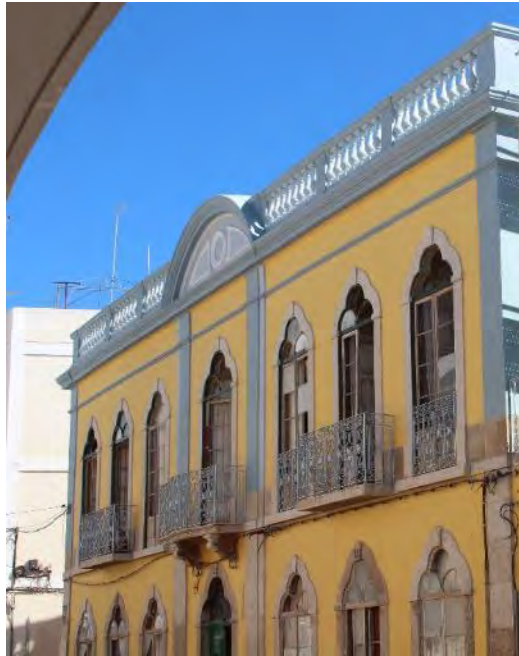
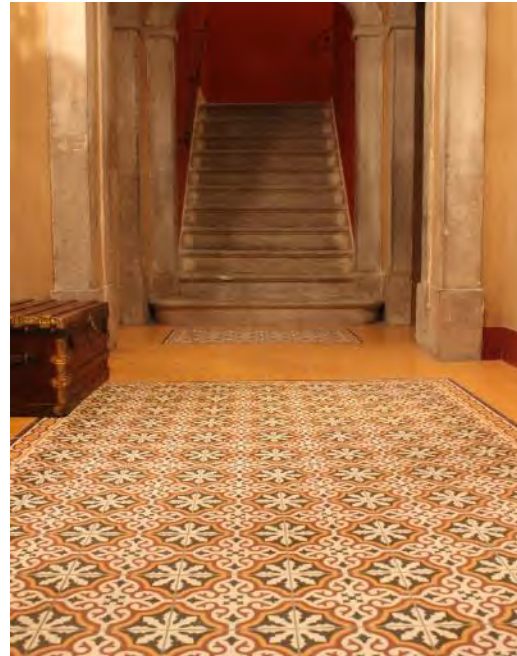
Figure 25\_ Refurbished building

The bays have stone lintel of three lobes. On the first floor all the main façade of the gaps have cast iron railings, richly ornamented (Figure 25).

The building was in a state of degradation and abandonment. Thanks to this intervention today we have a building that in addition to undertaking a hotel function displays a general state of preservation. The rehabilitation of the main structural elements, as was the case of roofs and floors, allows the building has 30 more years of life.

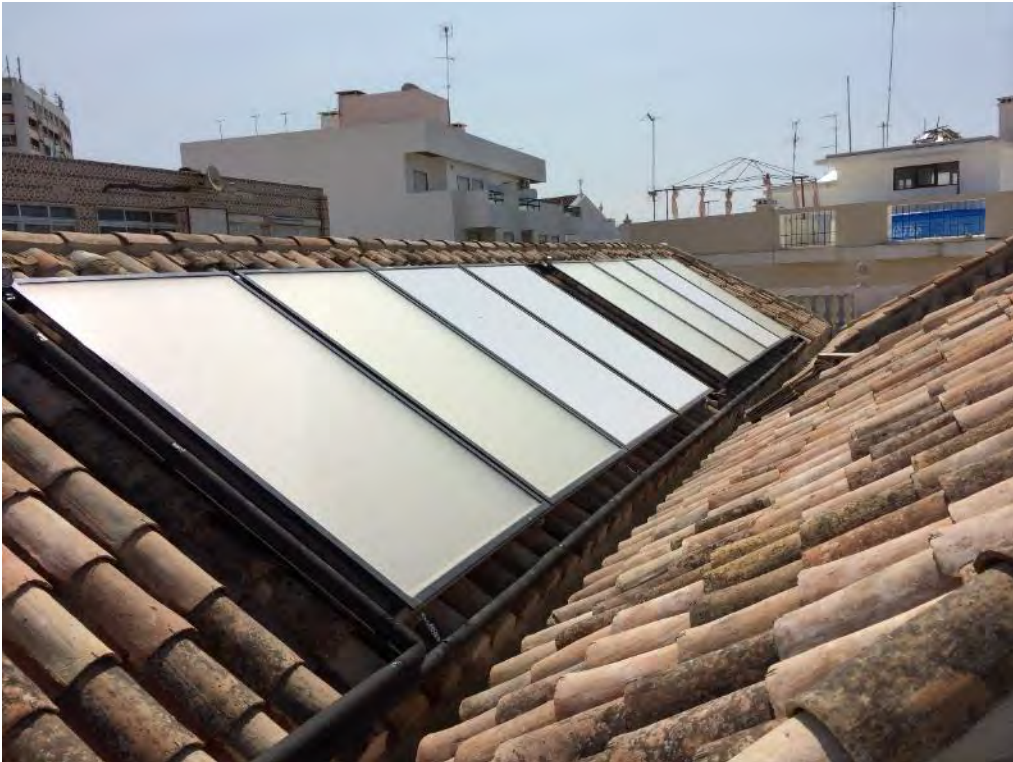
Figure 32\_ Solar panels on the roof

The heating of hot water is made with solar panels in an area of 16m<sup>2</sup>, installed on the rooftop (Figure 31) and with the support of two tanks of 1000 liters each. The building has a hot water recirculation system so there is no waste of water. All taps of sinks and showers are timed (30s).
